Manhole Inspection Summary

Manhole # S29K__064MH

Insp Date: **1/27/09 12:39 PM**

Location Address: **645 Bankard LN**

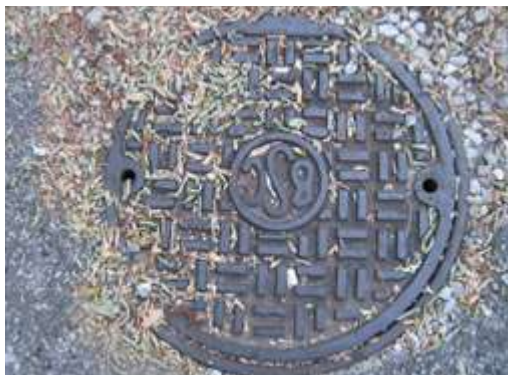
Misc

cover

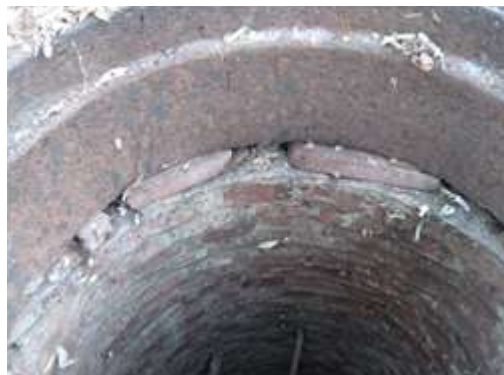
Defect 1

Frame Offset: **1** (in.) Condition: ☐ Sound ☐ Cracked ☒ **Leaks**

Condition: ☐ Sound ☐ Cracked ☐ Root Intrusion ☒ **Loose Brick** ☒ **Deteriorated**

frame offset 1 inch, chimney deteriorated at frame joint

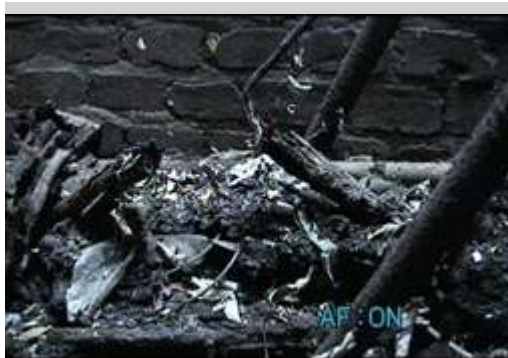
Defect 3

Condition: ☐ Sound ☐ Cracked ☐ Root Intrusion ☐ Deteriorated ☐ Leaks ☒ **Debris**

channel debris

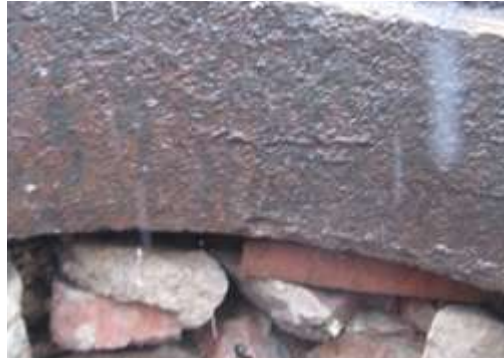
Defect 2

Infiltration: ☐ None ☒ **Joint** ☒ **Cracks** ☒ **Mortar** ☐ Roots ☐ Wall

frame infiltration at cover, chimney infiltration at frame joint, cracks and mortar
